THE EFFECT OF SLAMMING IMPACT ON OUT-OF-AUTOCLAVE CURED PREPREGS OF GFRP COMPOSITE PANELS FOR HULLS

Abstract

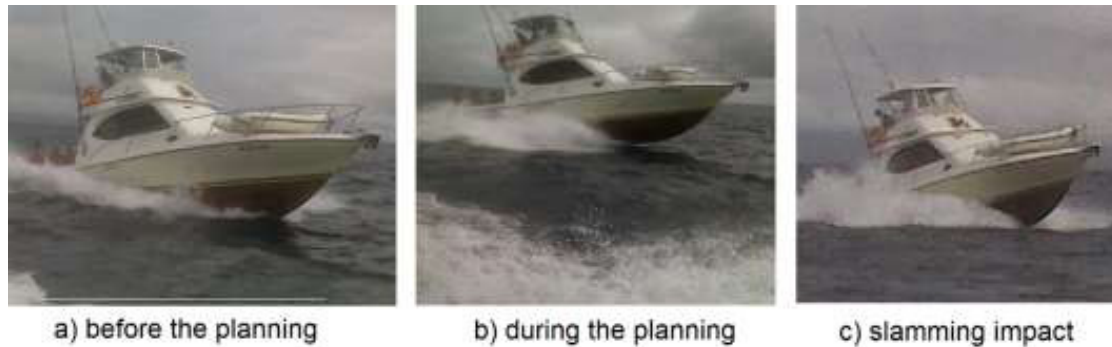
Figure 1. Navigation of the boat "Bite Me"

In Figure 3, three moments of navigation of the SB "Bite Me" are shown [3]; these were observed during a sea trial to determine its behavior in the slamming impact produced by the planing condition of the vessel. The phenomenon of slamming consists of three clearly identified moments: in a), the vessel is gaining hydrodynamic lift; then, in b), it reaches the critical point at which the bow rises. Breaking the equilibrium, it falls, hitting the sea with the bottom of the hull, over times equivalent to microseconds, thereby generating a high pressure of slamming [4-5].
